Heath Creek Streambank Stabilization

Location:
Desoto, Texas

Products:
Flexamat Plus
Scourlok

Application:
Streambank Stabilization

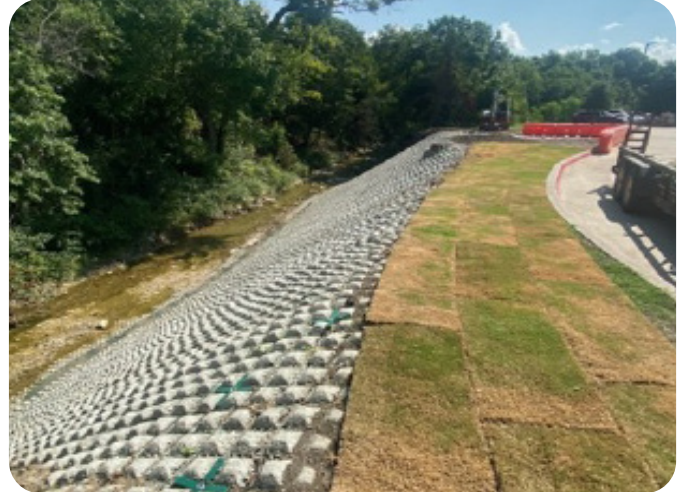
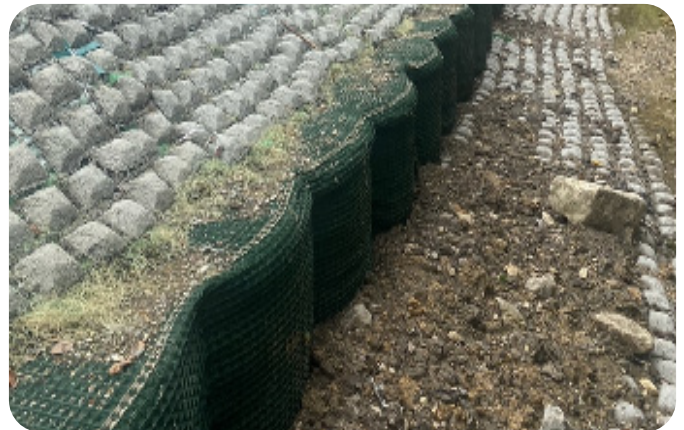
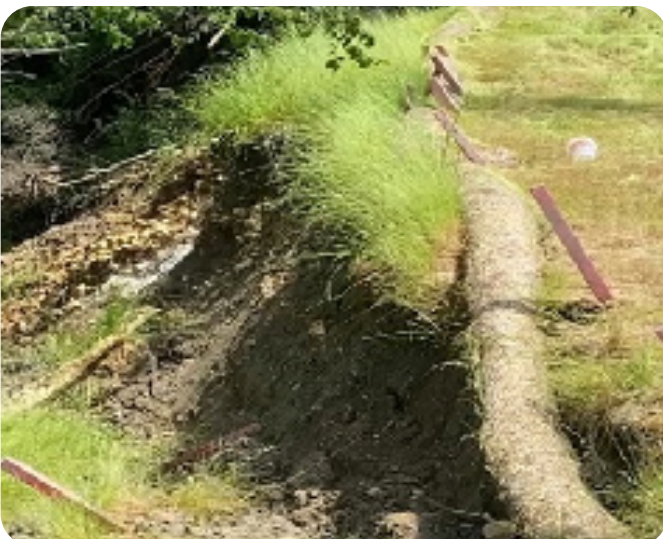
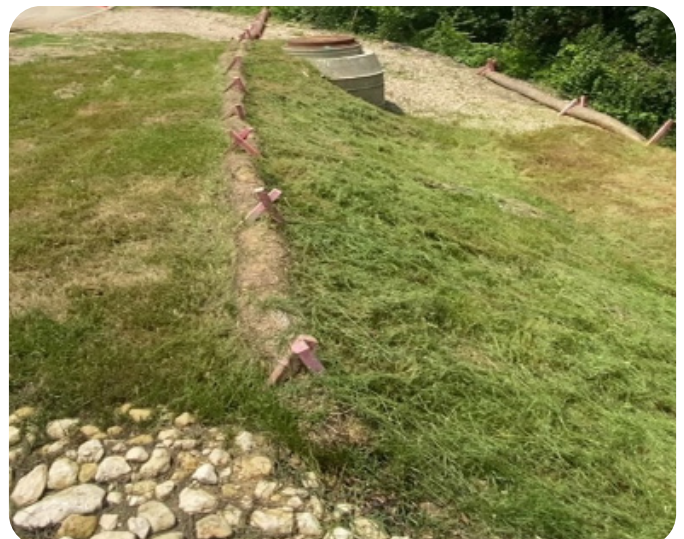
Engineers with the City of Desoto, Texas were struggling to meet their budget allowance for repairing an eroded streambank near a local church. The erosion became so severe that the parking lot of the church was in danger of falling into the creek below. Originally, the Engineers considered repairing the wall with gabions, but the estimated cost was far outside their budget.

The city approached Hanes Geo Components in search of an alternate solution. Our team, along with Shield Engineering, proposed a redesign utilizing Scourlok to protect the toe while reducing the slope ratio from 1:1 to 1.5:1. The rest of the slope would be protected with Flexamat and Crossplate anchors. The new solution was 1/3 of the cost of the gabion proposal, resulting in significant cost savings for the city while maintaining the integrity of the church parking lot.
