## Sedona Lakes MUD #1, Pond 5

**Product and Quantity:**  
Armormax®- 5,000 ft<sup>2</sup>

**Application:**  
Shoreline Stabilization

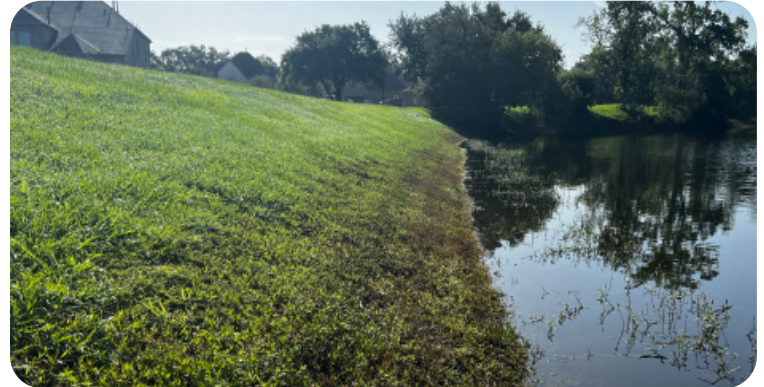
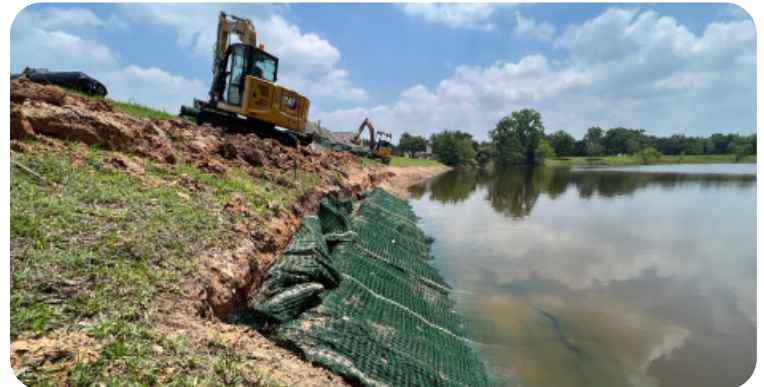
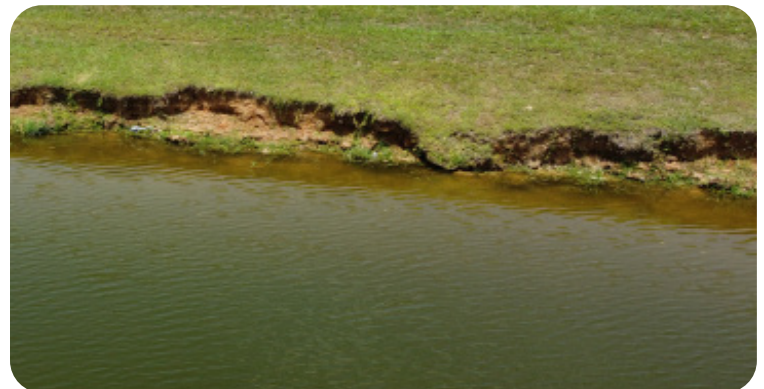
The Armormax system is a combination of the Propex Pyramat75 high performance turf reinforcement mat along with corrosion resistant engineered earth anchors (EEA). On the Pond 5 Shoreline Stabilization project, the Armormax system also incorporated a burrito stone wrapped section with an EEA to protect the toe of the slope, underwater.

The Armormax system installed easily and quickly established vegetation, naturally blending into the surrounding slopes. The pond shoreline is protected, allowing residents to walk down to the pond edge.

Engineers for Sedona Lakes MUD #1, Pond 5, faced a reoccurring challenge of sloughing of the edges of an amenity detention pond. Sloughing of the shoreline edge occurs as the pond fills with water after a rain event, the water recedes, leaving the heavy, unprotected, saturated soil at the edge falls into the pond. Wave action against the soil edge accelerates the erosion and deterioration of the pond edge.

This pond shoreline has a 3H:1V slope descending from the top of the slope with a walking trail to the water's edge. As the edge drop off to the water surface became higher, residents could no longer safely walk down to the pond edge. The engineering team working for the MUD was looking for options that provided stability of the pond edge, facilitated vegetation establishment, and met the budget needs of the client.
