## Ted Craig Regional Park Pond Shoreline Reclamation

**Location:** Brea, CA    **Product:** Flexaroll

**Application:** Shoreline/Streambanks

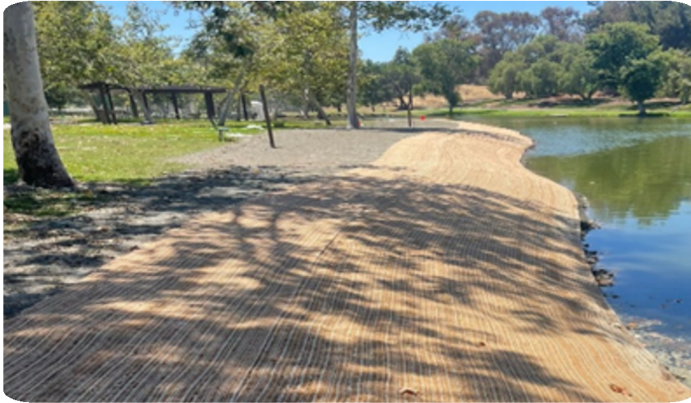
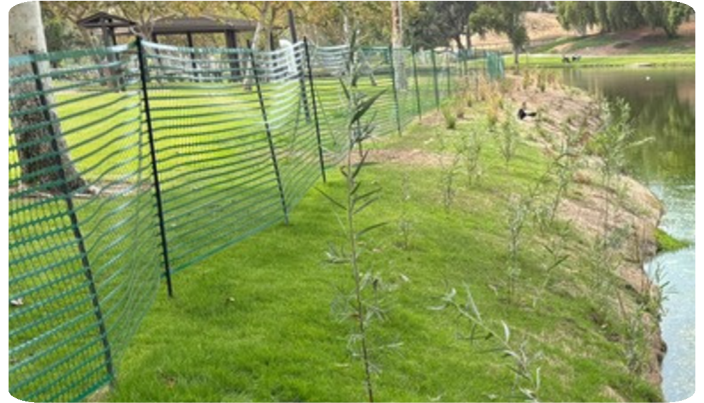
The toe of the shoreline at Craig Regional Park Pond was eroding due to heavy stormwater flows entering the pond. This erosion resulted in the loss of soil and gradual degradation of the shoreline.

To restore the shoreline and prevent future erosion, a stable and durable material was needed to rebuild the toe of the slope. Flexaroll, a tied concrete block mat system with an integrated geotextile liner, was selected for the job.

The geotextile layer on the water-facing side of Flexaroll helped contain dredged material placed inside the core, forming a solid foundation for the new slope. Additional dredged material was placed behind the Flexaroll to rebuild the slope and recover lost pond depth.

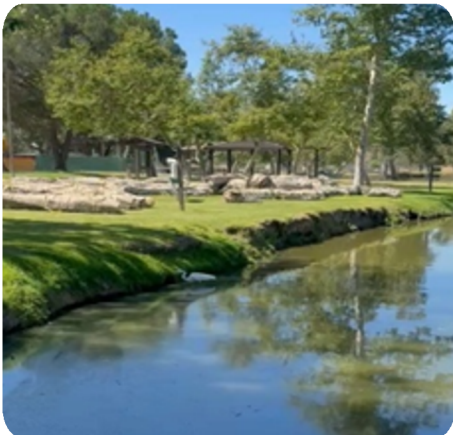
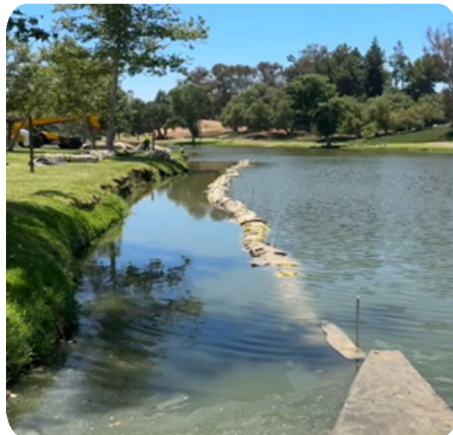
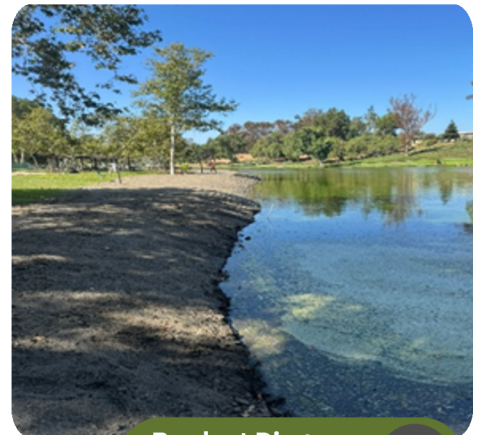
With the new slope established and the pond dredged, Orange County Public Works successfully restored the pond to its original size and depth.
